**Expert Report of Dr. Quinn  
Horn, Ph.D., P.E.**

**Marcellin, et al., Plaintiffs**

**vs.**

**HP, Inc., and Staples, Inc.**

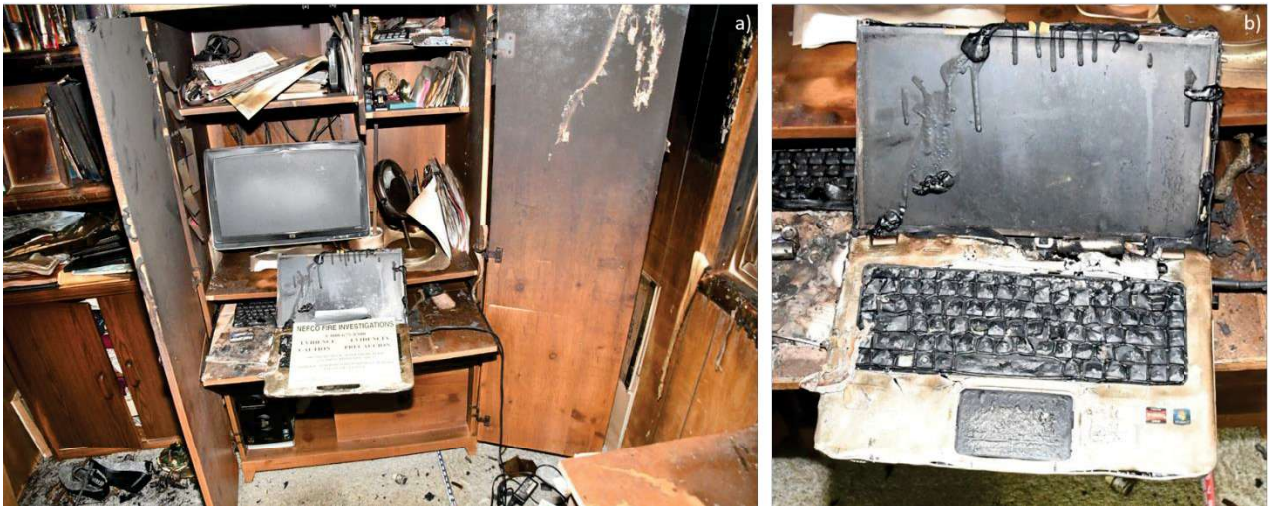
In the office, the remains of a desk, desk chair, armoire, a bookshelf, and closet were observed. At the time of the inspection, Door 1 was opened, and Door 2, which led to a bathroom, was closed. The wood closet door, with an attached ironing board, was swung open, and the doors to the armoire were also angled open. An HP Pavilion DV6 notebook (henceforth referred to as the Subject Notebook) was observed on a shelf in the armoire, and the notebook was connected to a charger at the time of the inspection. The screen of the notebook was open. The polymeric casing around the screen, the keyboard, and the remaining notebook housing materials had melted, and there was a rupture in the notebook housing in the region of the battery pack. Two battery cell cans were observed remaining inside the battery compartment of the notebook. These cell cans appeared to have decrimped and ruptured, and windings had been ejected. Images of the armoire and Subject Notebook are shown in Figure 4.

Figure 4. Scene photographs of a) the armoire (Greg Gorbett image DSC 1600) and b) HP Pavilion DV6 notebook computer (Greg Gorbett image 1628).

At the scene and lab examinations, it was observed that the plastic housing of the notebook exterior (around the screen) as well as the keyboard had melted during the incident (see Figure 4b, where the material had dripped down the surface of the screen and also on the sides of the notebook). The nature of the melting and resolidification of these materials suggests top down heating, likely from the fire or radiated heat from the hot gas layer of the fire.

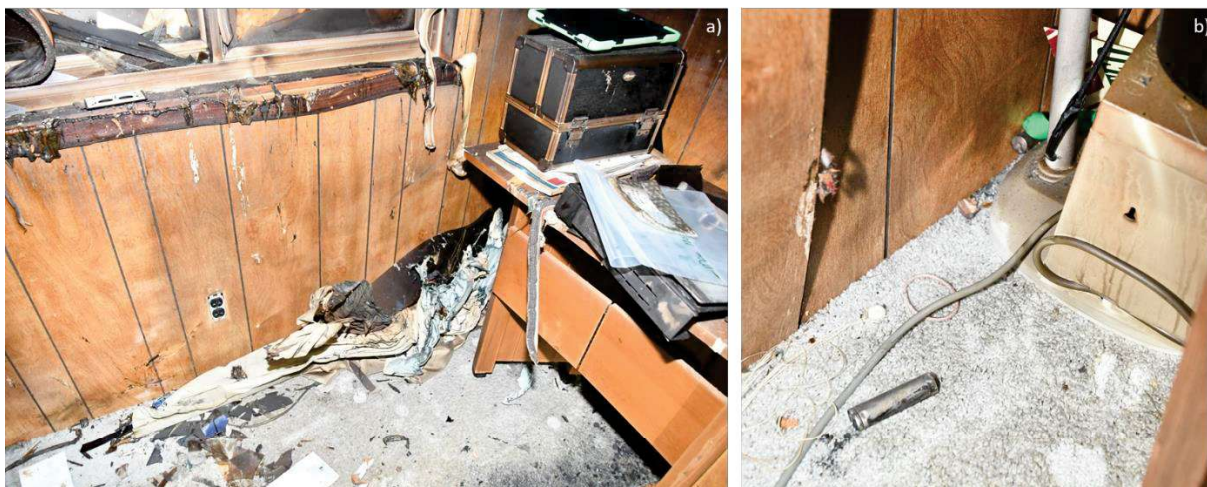
During the scene inspection, the desk was moved away from the wall in order to investigate the regions of the flooring underneath and behind the desk surface. During this process, sections of curtains and other debris were observed resting on the floor behind the desk. When this debris was cleared, two battery cells were found in the corner of the room. Both cell cans had decrimped and ejected their internal windings, and some of these windings were found nearby the cells. There was no thermal damage or ignition of the carpet, flooring, or other combustibles in the region where these cells were observed. Images of this region of the office are shown in Figure 6.

Figure 6. Photographs of the region of the office behind the desk. Curtains other debris (image a, Greg Gorbett photo DSC 1824) and two battery cells (image b, Greg Gorbett photo DSC 1833) were observed.

Cells 5 and 6 were found in the back corner of the office behind the desk. This region of the room exhibited the least thermal damage, and no combustibles near the floor level (such as the carpet, wooden desk, or desk chair) appeared to ignite during the event. This suggests that, at least by the time the cell cans reached their final location, they did not have enough energy to ignite nearby combustibles and materially spread the fire. Cells 5 and 6 also displayed signs of crimp release (see Figure 16), where the positive top cap assembly had ejected. Can fragments consisted with these cell top caps as well as winding fragments (that likely belong to some combination of Cells 3, 4, 5, and 6) were found at locations C, E, A/F, and I. While Cells 5 and 6 clearly experienced an energetic failure, the fact they were found across the room, with other cell components in disparate locations, suggest that the notebook housing was already compromised at the time these cells experienced thermal runaway (thus enabling their escape due to the mechanical forces acting

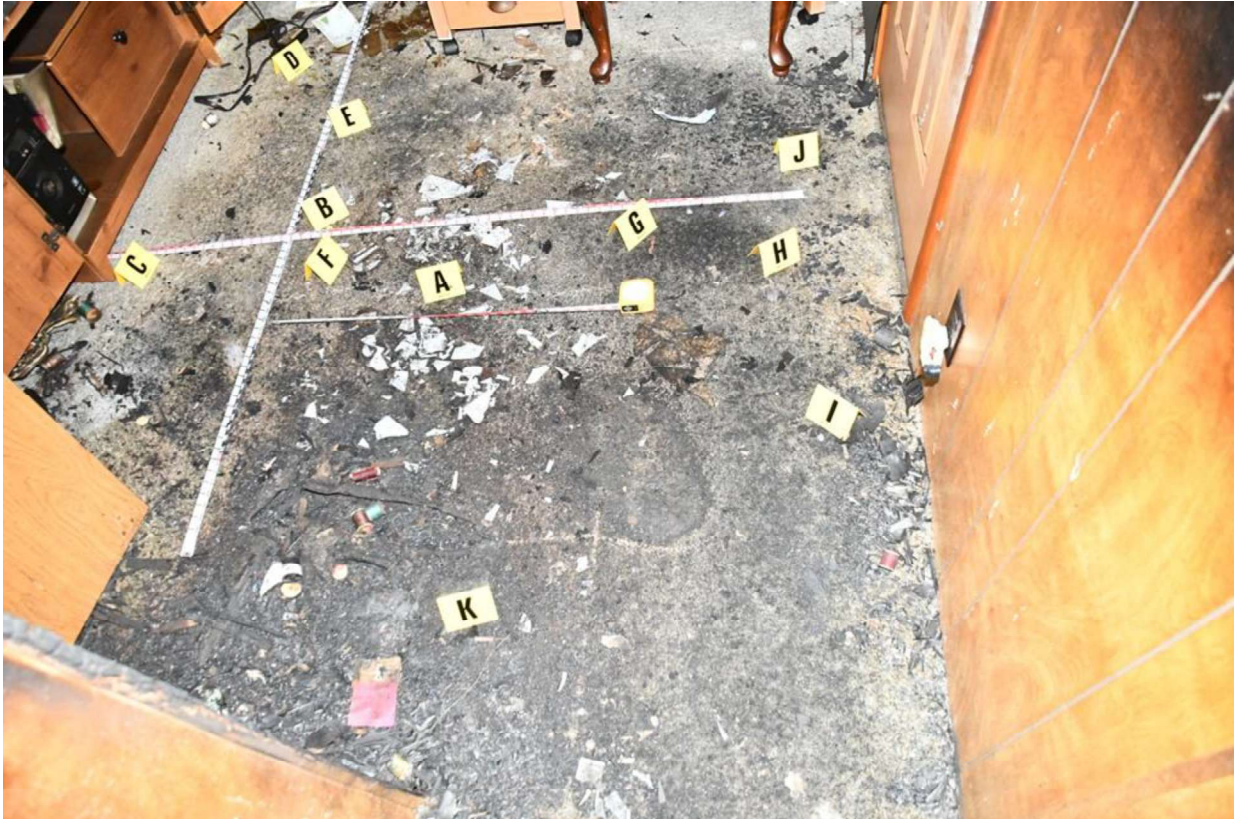
Various pieces of additional evidence, labeled A – L in Figure 1, were found on the floor scattered throughout the center of the room. An overview of these items is shown in Figure 7.

Figure 7. Photograph of the floor of the office (Greg Gorbett photo DSC 1732), with evidence labels for recovered items from the scene.

Partial ejected battery cell windings were observed at points H, I, J, and K, and cell can components/remnants were observed at points A, C, and E. The remains of two battery cells were found at point F. A close-up image of these cells is shown in Figure 8. The remains of a purple cell wrapper were found adhered to each of the cell cans, and it appeared that these cells were externally connected in parallel. An additional battery cell positive cap was found loosely adhered to one of the cell cans. This cap had a five-vent hole design.

In addition to the location and condition of the cell cans as observed at the scene, it is unlikely that any individual windings fragment, as were observed in evidence locations A – L in the scene photographs, would have had enough energy and thermal mass to ignite combustibles after traveling across the room. In my experience, based on extensive review of 18650 battery cells that have been subjected to UL 1642-style thermal runaway testing, when an 18650 battery cell experiences thermal runaway, hot gases, sparks, and particles will be ejected during the venting process. These materials can ignite combustibles that are directly nearby the failing cell, as these ejecta have not yet had time to cool as they travel; however, in the cases where pressure builds up in the cell such that decrimping occurs and the top cap is detached, subsequently enabling ejection of large portions of the cell windings, the cell can remains have less thermal mass and the ejected windings will cool quickly. In this case, where small fragments of windings were found in disparate locations throughout the room, it appears highly unlikely that any individual windings fragment would have had sustained the energy required to ignite materials across the room of origin from where the cells experienced thermal runaway inside the notebook.

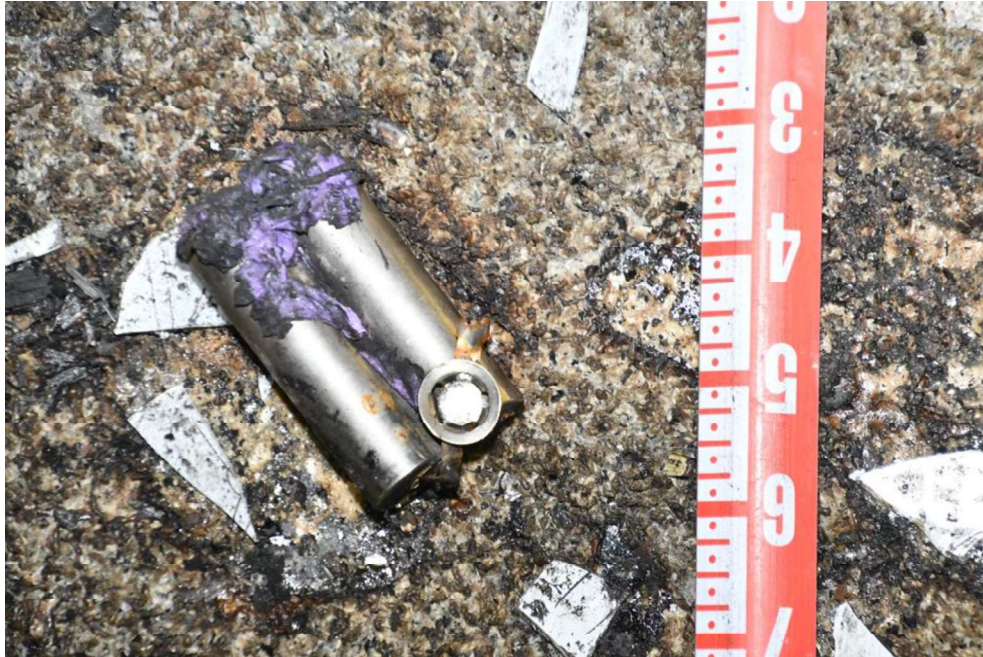
Figure 8. Photograph of the two battery cells with purple wrapper remnants found at point F on the floor of the office (Greg Gorbett photo DSC 1721).

Cells 1 and 2, found at location F in the center of the room, still had large fractions of the cell wrapper adhered to the cell cans, were still tabbed externally in their parallel configuration, and, based on the limited photographs of 2D X-ray imaging available for review, appeared to have almost entirely intact electrodes internally (see Figure 11 and Figure 12). These observations indicate that these cells did not experience thermal runaway. If these cells had experienced a failure that initiated the fire, it is highly unlikely that the amount of intact wrapper and intact

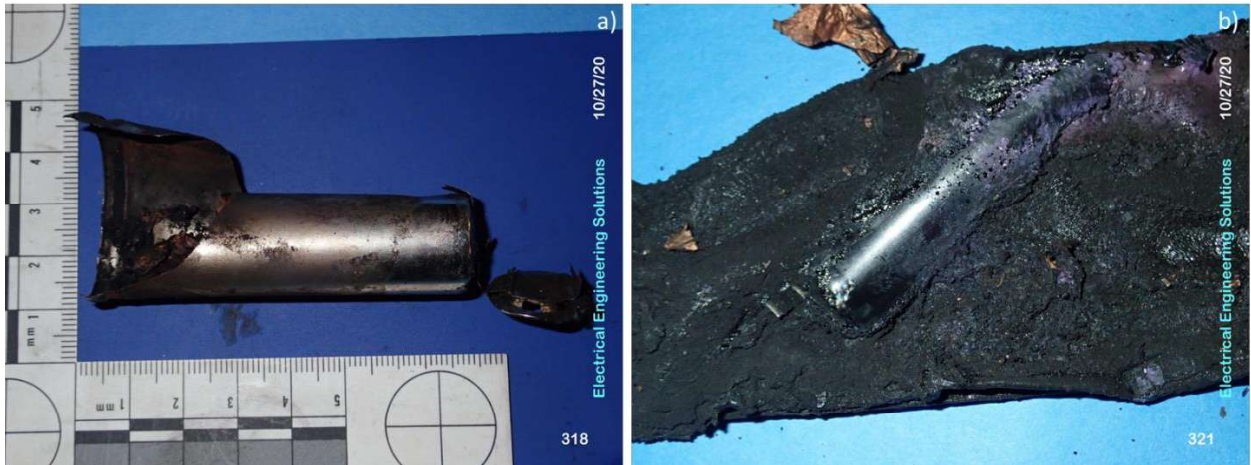
Both cell cans had ruptured and torn, decrimping and detaching the positive top cap assembly in the process. Some windings remains were observed inside the Cell 3 can, but limited windings were found in the Cell 4 can or in the region directly around the notebook – most of the recovered windings were found on the floor on the other side of the room. Additional photographs of the two cells, after they were extracted from the notebook, are shown in Figure 15. Purple wrapper residue was observed on the surface of Cell 4.

Figure 15. Photographs of a) Cell 3 (Don Galler photo 318) and b) Cell 4 (Don Galler photo 321) of the subject battery pack after extraction from the Subject Notebook.

The remaining cans of Cells 3 and 4 were found in the battery pack region of the notebook. These cells had also experienced crimp release and high energy thermal runaway failures; however, a majority of their windings and can components were likely found in the center of the room, again suggesting that the notebook housing was compromised prior to their failure. Cell 4, which was observed towards the bottom of the notebook facing the armoire shelf, still had purple wrapper residue on the surface of the cell can, indicating that the cell ejected its contents, and their thermal mass, quickly enough such that the cell surface temperatures did not reach a point where the wrapper was consumed. Wrapper consumption would be expected if the fire was initiating in that cell.

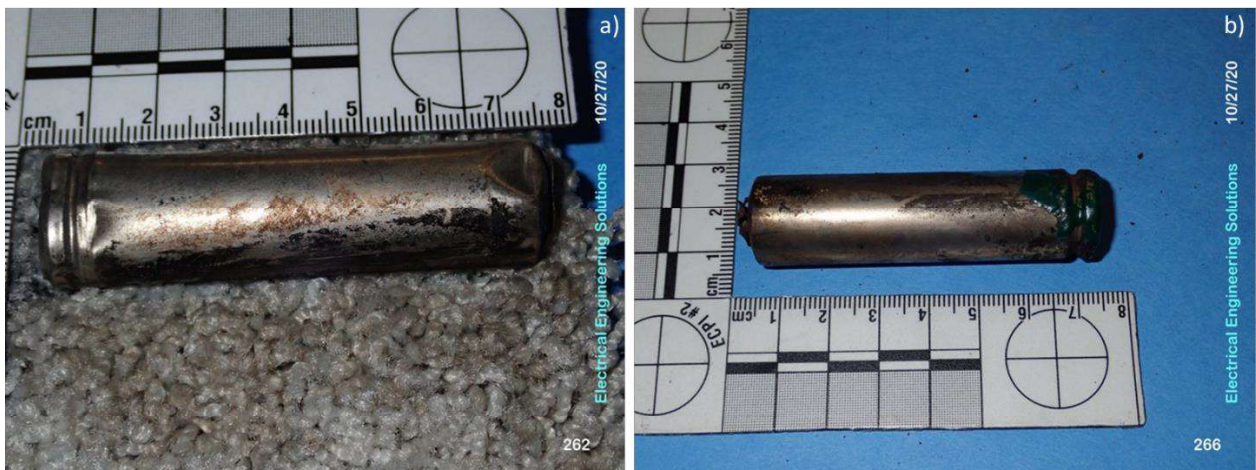
Cells 5 and 6, recovered in the corner of the office behind the desk during the scene inspection, were also examined at the lab inspection. Photographs of these cells are shown in Figure 16. Both cell cans had decrimped, and the positive top cap assembly had detached from the cell cans. No wrapper residue was observed on either cell; however, a thick green polymeric residue was observed to be melted to the Cell 6 can. The color of this substance was similar to that of a green melted handle to a bag recovered from the same area of the office, as shown in Figure 17.

Figure 16. Photographs of a) Cell 5 (Don Galler photo 262) and b) Cell 6 (Don Galler photo 266) of the subject battery pack.

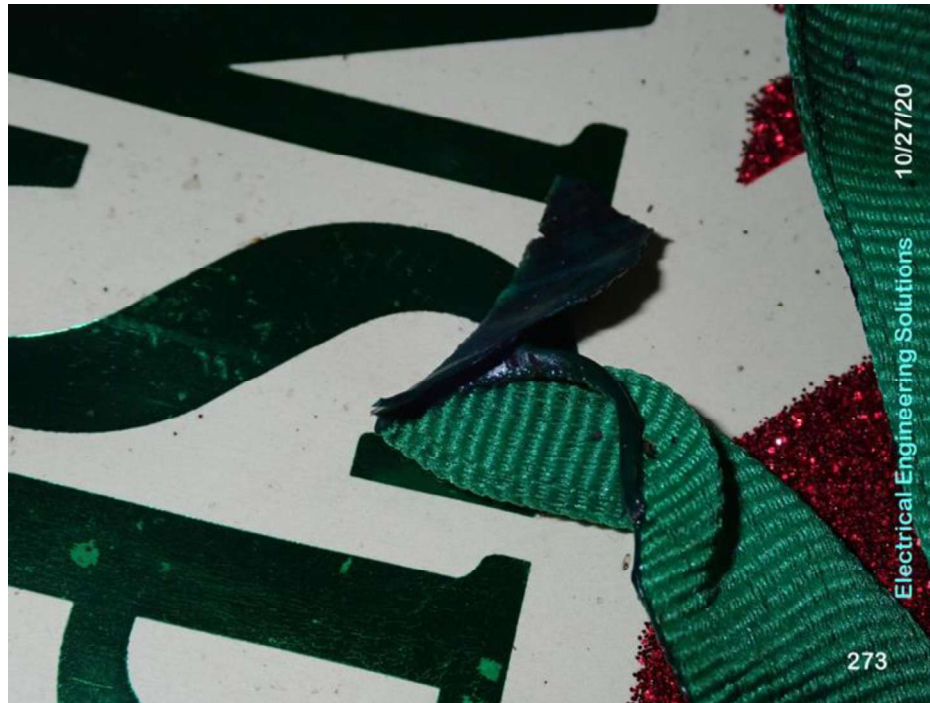
Figure 17. Photograph of a bag recovered in the corner of the office (Don Galler photo 273)

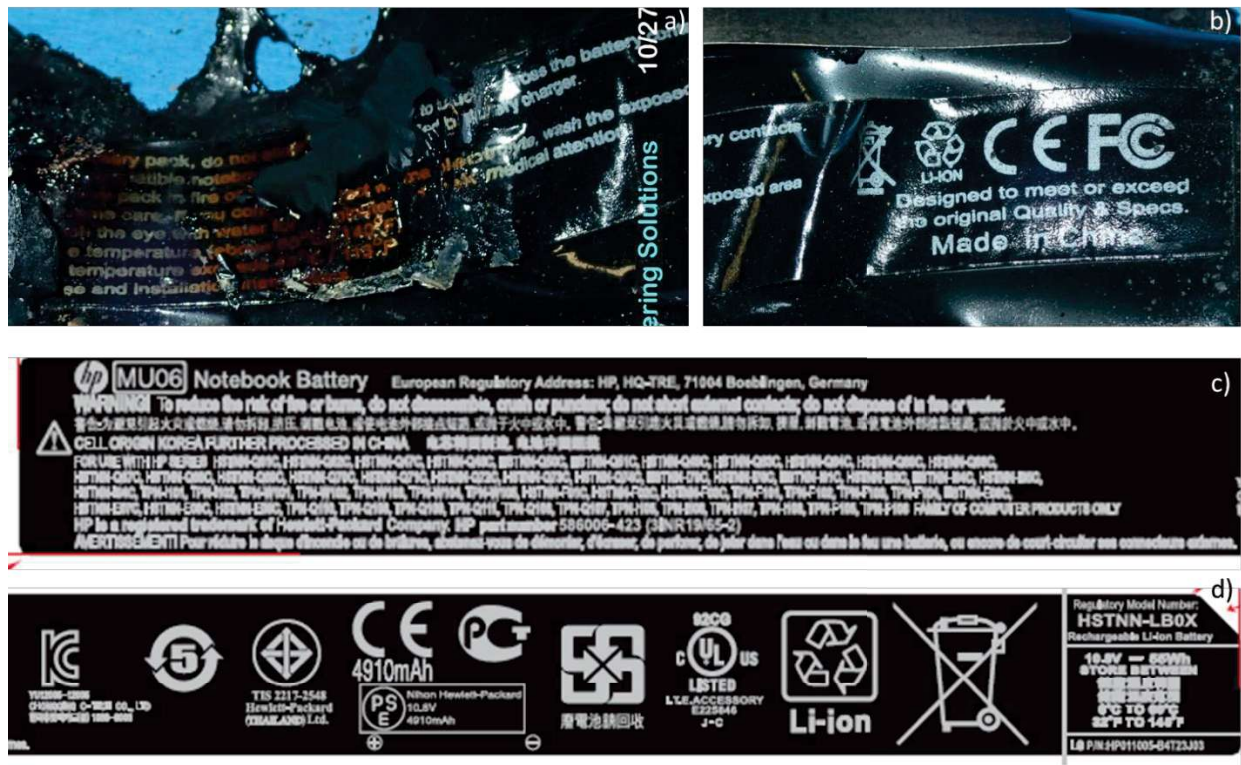
Figure 19. Comparison of the battery pack labeling in a) the subject pack (Don Galler photo 354), b) the subject pack (Don Galler photo 355), c) the original battery pack specifications (HP 01324) and d) the original battery pack specifications (HP 01324)

The remaining labeling on the subject pack appears inconsistent with that of the original battery pack, per the specifications. Labels are provided as part of the certification process, making them a known consistent characteristic across pack models, so the difference in labeling between the subject pack and the original battery pack is demonstrative of the fact that the subject battery packs was not an HP approved battery pack for the HP Pavilion DV6 notebook computer. This was further corroborated by Lee Atkinson, HP designee, during his deposition taken August 2, 2023.
